Manhole Inspection Summary

Manhole # S55I__038MH

Insp Date: **5/28/08 2:09 PM**

Location Address: **side of 3517 eastern ave**

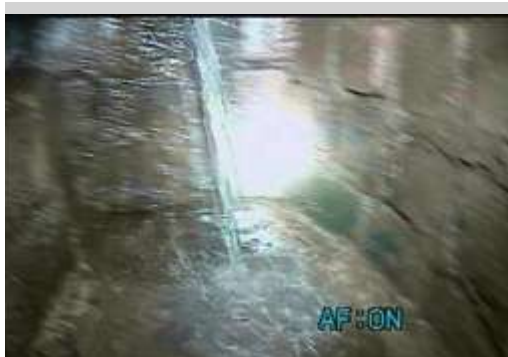
Misc.

channel below 3 Oclock (no drop in @ 3)

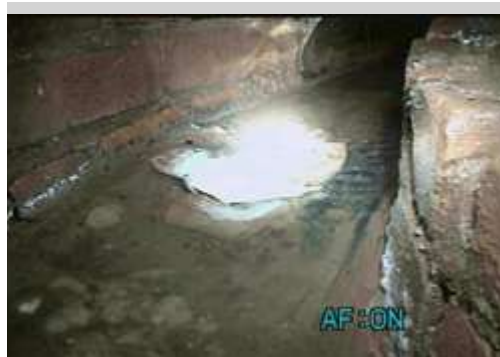
Miscellaneous

channel debris

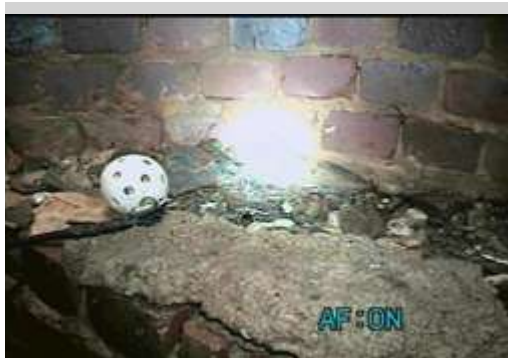
Defect 4

Condition: ☐ Sound ☐ Cracked ☐ Root Intrusion ☐ Deteriorated ☐ Leaks ☒ **Debris**

bench debris

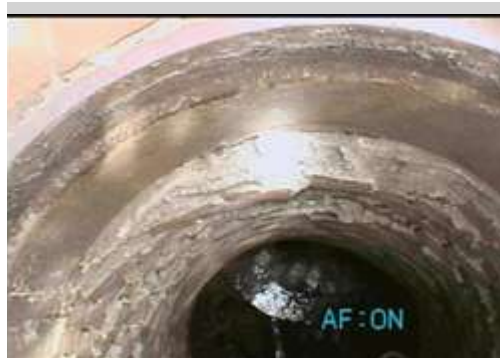
Defect 3

Offset: **2** (in.)

offset

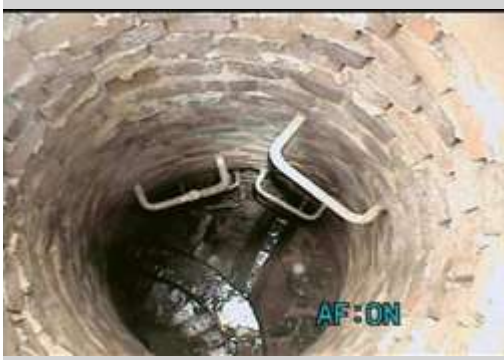
Defect 2

☒ **Corroded**

steps

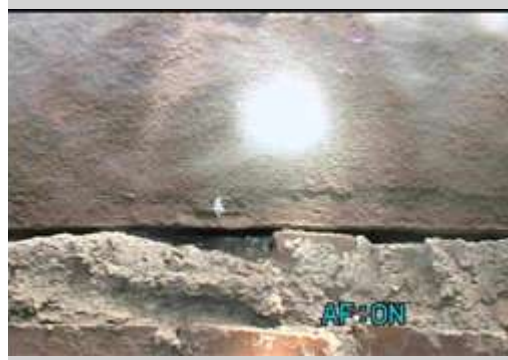
Defect 1

Condition: ☐ Sound ☐ Cracked ☐ Root Intrusion ☒ **Loose Brick** ☐ Deteriorated

corbel loose bricks

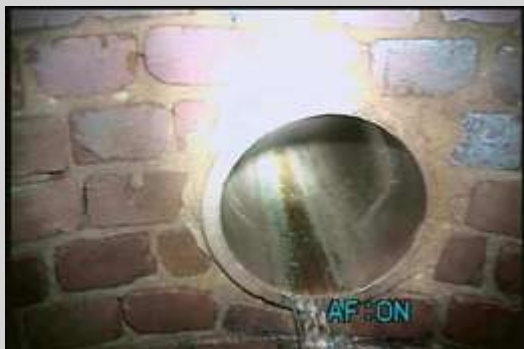
3 O'Clock Inflow

its not a drop there is no other pipe below
